title: AIRFIELD PAVEMENT CONDITION SURVEY AND PAVEMENT EVALUATION,
USMCAS, EL TORO, CALIFORNIA, by

date: DECEMBER 1975,

sponsor: NAVAL FACILITIES ENGINEERING COMMAND

CIVIL ENGINEERING LABORATORY

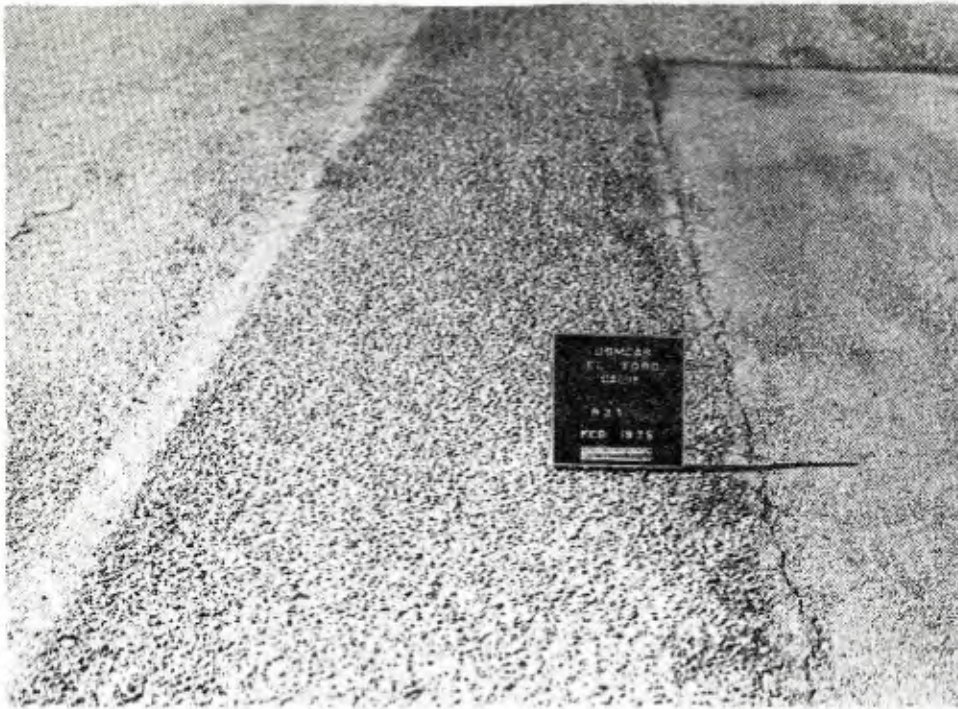
FIGURE 3. SURFACE CONDITION ASPHALTIC CONCRETE, DISCRETE AREA R3-1

Defect Type	Length or Area of Sampled Defects	Total Length or Area of All Defects: (c) x Ratio	Defect Density (per 10 sq. ft.) 10 d/a	Defect Severity Weight	Weighted Defect Density: (e) x (f)
	(c)	(d)	(e)	(f)	(g)
T.C., L.C. or LCJ*	2,170 ft.	31,465 ft.	0.699	3.0	2.01
Reflection Crack					
Faulting					
Patching	880 ft. ²	12,670 ft. ²	0.270	3.5	0.95
Settlement or Depression					
Pattern Cracking	100 ft. ²	1,450 ft. ²	0.031	3.0	0.09
Rutting					
Raveling	4,272 ft. ²	61,944 ft. ²	1.318	7.0	9.23
Erosion-Jet Blast					
Oil Spillage					
Broken-up Area					
Total					12.28A
Remarks on Pavement Condition					
Surface aggregate is completely exposed and devoid of bitumen. Cracks have some vegetation growing in them. Raveling was detected in the worst areas where loss of surface fines was noted. Almost the entire area could be considered to be in a state of incipient raveling. See Figure 3.

In the asphaltic concrete portions of Runway 3-21, the weighted defect density increased from 8.40A to 12.28A with the increase being mainly attributable to an increase in raveling and transverse and longitudinal cracking. The asphaltic concrete portion of Runway 7R-25L showed a total weighted defect density increase from 2.27A to 3.93A. The principal contributors to this increase were an increase in the amount of reflection cracking and pattern cracking. The asphaltic concrete portion of Runway 16L-34R had an increase in weighted defect density from 2.97A to 5.13A. An increase in the amount of pattern and reflection cracking contributed most of this change.

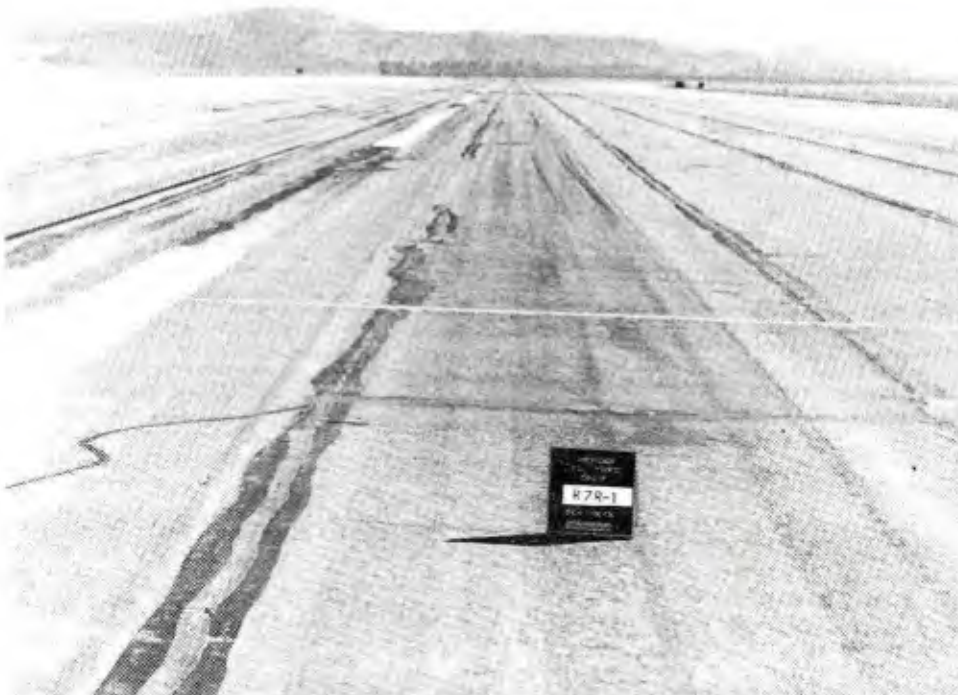
FIGURE 4. REFLECTION CRACKS, DISCRETE AREA R7R-1

Defect Type	Length or Area of Sampled Defects	Total Length or Area of All Defects (c) x Ratio	Defect Density (per 10 sq. ft.) 10 d/a	Defect Severity Weight	Weighted Defect Density (e) x (f)
	(c)	(d)	(e)	(f)	(g)
T.C., L.C. or LCJ*	676 ft.	10,985 ft.	0.169	3.0	0.51
Reflection Crack	5,775 ft.	93,844 ft.	1.444	1.5	2.17
Faulting					
Patching					
Settlement or Depression					
Pattern Cracking	1,650 ft. ²	26,813 ft. ²	0.413	3.0	1.24
Rutting					
Raveling	8 ft. ²	130 ft. ²	0.002	7.0	0.01
Erosion-Jet Blast					
Oil Spillage					
Broken-up Area					
Total					3.93A
Remarks on Pavement Condition Pattern cracking occurred along reflection cracks. Reflection cracks have been sealed and resealed. There is a large buildup of joint seal material on the pavement surface. See Figure 4.
